IGNITION  
PARTS

## TECHNICAL INFORMATION SHEET

### FLASHOVER

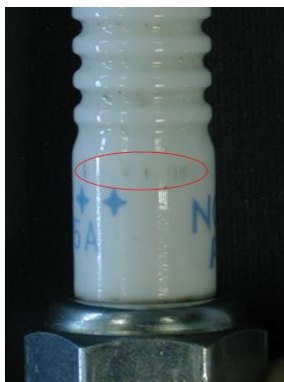
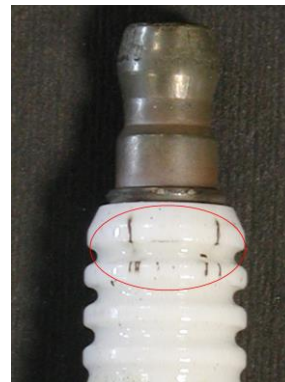
Flashover is the result of the HT voltage taking an easier path to earth instead of jumping the spark plug gap. In this case, it is from the top terminal of the plug to the metal shell down the outside of the 'ceramic' insulator.

This discharge can often leave black markings 'etched' into the insulator over a period of time.

The symptom is caused by a poor connection on to the spark plug top terminal and/or poor sealing of the boot on to the plug.

Check the overall condition of the HT connection (caps/covers/boots/leads) and that they are secure on to the top of the plugs. Ensure the sealing arrangement fits tightly around the ceramic insulator of the spark plugs – sealing effectiveness can reduce through ageing. If flashover has been occurring over a long period (black lines will clearly be seen on the spark plug insulator) the cover may be damaged. Renew deteriorated items as necessary. Make sure components are clean and dry upon assembly.
