IGNITION  
PARTS

## TECHNICAL INFORMATION SHEET

### CARBON BUILD UP AND ITS AFFECT ON GLOW PLUGS

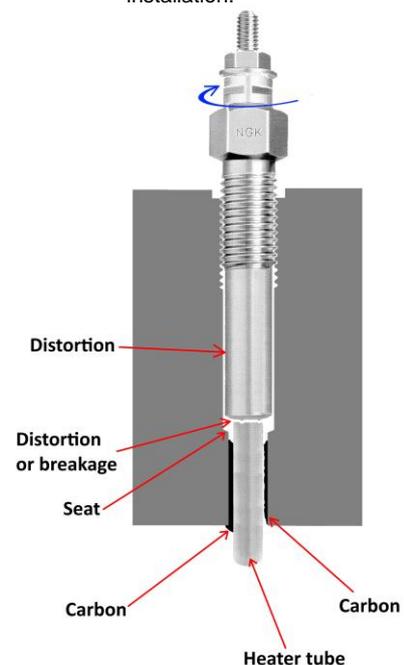
As with any component, care should be taken whilst fitting as in addition to poor sealing and premature failure, obstructions in the glow hole can cause distortion/breakage of a glow plug. This is more likely in modern engines due to the longer and smaller diameter plug designs demanded by many vehicle manufacturers.

Possible damage caused to a new glow plug during installation.

Although best to ream in any case, a good method of ensuring no obstruction or thread damage exists is to install the glow plug by hand until it contacts the taper seat - prior to final tightening with a torque wrench.
