## TECHNICAL INFORMATION SHEET

### OIL CONTAMINATION OF SENSORS

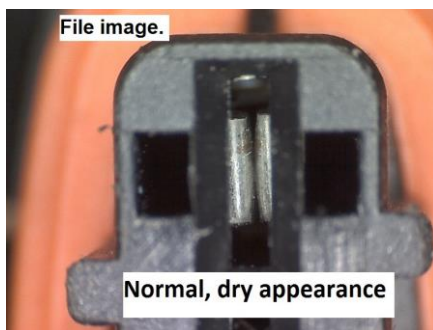
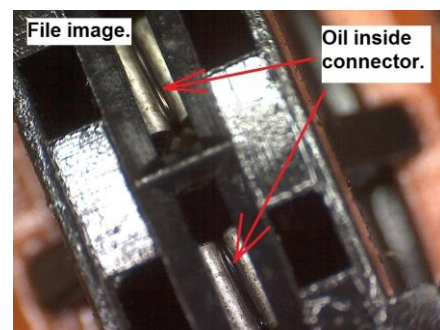
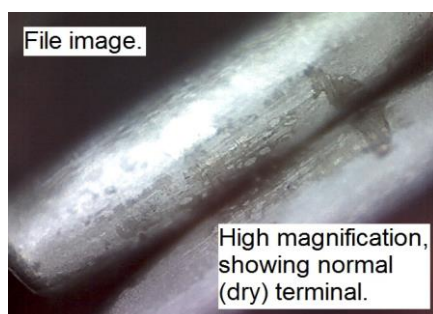
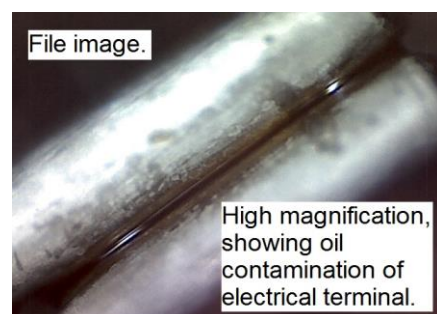
Although the outside of the connector may look dry, when unplugging the original Lambda sensor, carefully look inside the connector block for any oily residue, *however slight it might be*.

The inside of the connector should be bone dry. Tests have shown contamination to any degree can affect sensor operation.

Leaking engine oil can *enter the vehicle wiring loom*. It then travels by capillary action under the PVC insulation of the individual wires. It passes through the connector block, inside the wires where it can disrupt the low voltage signals or eventually end up actually inside the sensor itself. The delicate sensing material is then contaminated and impairs operation.

- Sensor replacement without addressing the source of oil contamination invariably results in reoccurrence of the problem.
